TEST REPORT No. 8103.1

Requested by:	Kenbrock Pty Ltd 22-24 Edson Road Dandenong South Vic 3175
on (date): Manufacturer:	4 May 2018 Kenbrock
Product Desc.:	Cushion Stone, Vinyl Tiles, PU Top Coa
Sampling details:	
Where:	At customer premises
Date:	7 May 2018
By whom:	customer (delivered by courier)

SUMMARY OF SLIP RESISTANCE TESTS PERFORMED:		
		Result	Class
AS 4586:2013	Slip resistance classification of new pedestrian surface materials		
	Appendix A: WET PENDULUM TEST METHOD (Slider 96):		
	Mean SRV:	39	P3
AS 4586:2013	Slip resistance classification of new pedestrian surface materials,		
(Amendment No. 1)	Appendix D: OIL-WET INCLINING PLATFORM TEST METHOD		
	Corrected mean overall acceptance angle:	19°	R 11

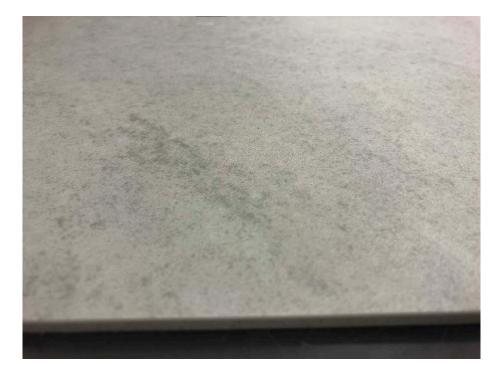
Top view
